# Ham Close Regeneration

Geo-environmental Report

Author: Enzygo

April 2022

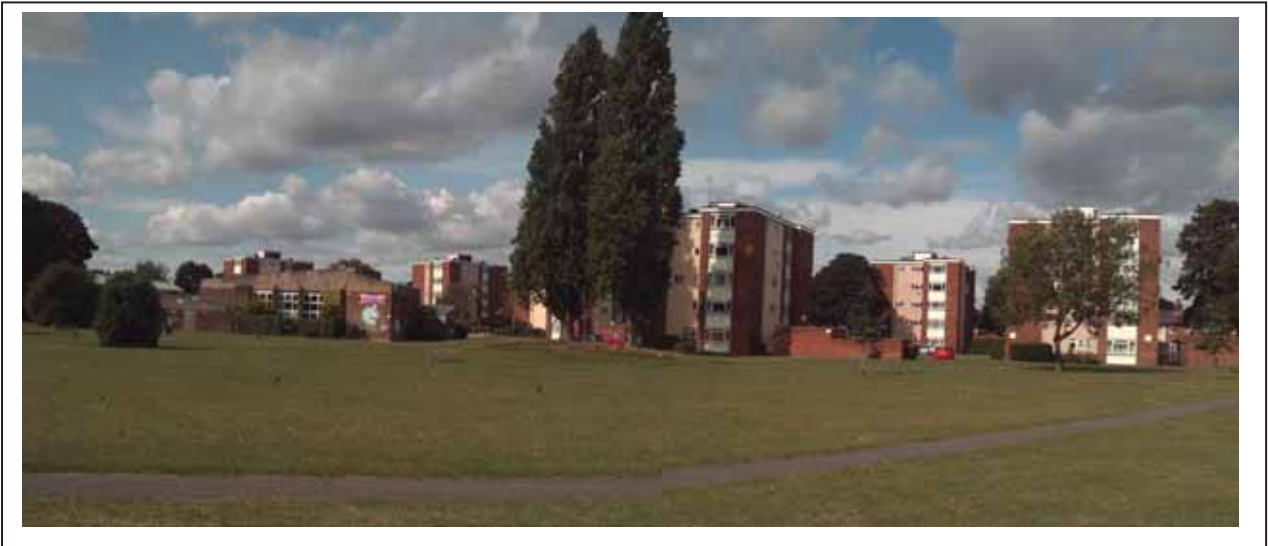
**Photograph 1: View of the site from the east**

The east end of the site is grassed communal open space with an asphalt surfaced car park in the southeast corner. There is an electricity sub-station in the service yard, immediately next to the southeast corner of the site.
